WHITMANS POND DAM

MA 00775

PHASE I INSPECTION REPORT
NATIONAL DAM INSPECTION PROGRAM

AUGUST 1980

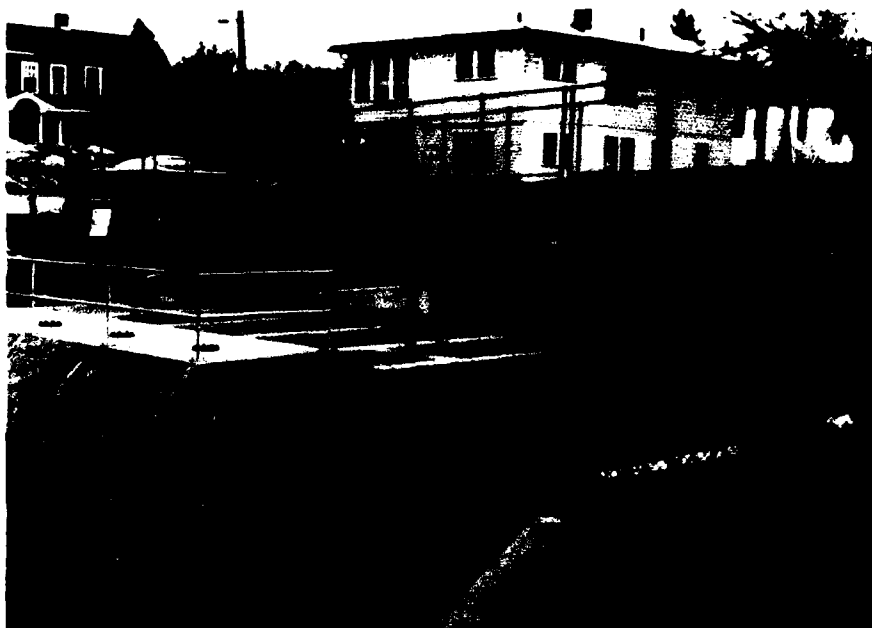
9. Downstream face of dam from left abutment

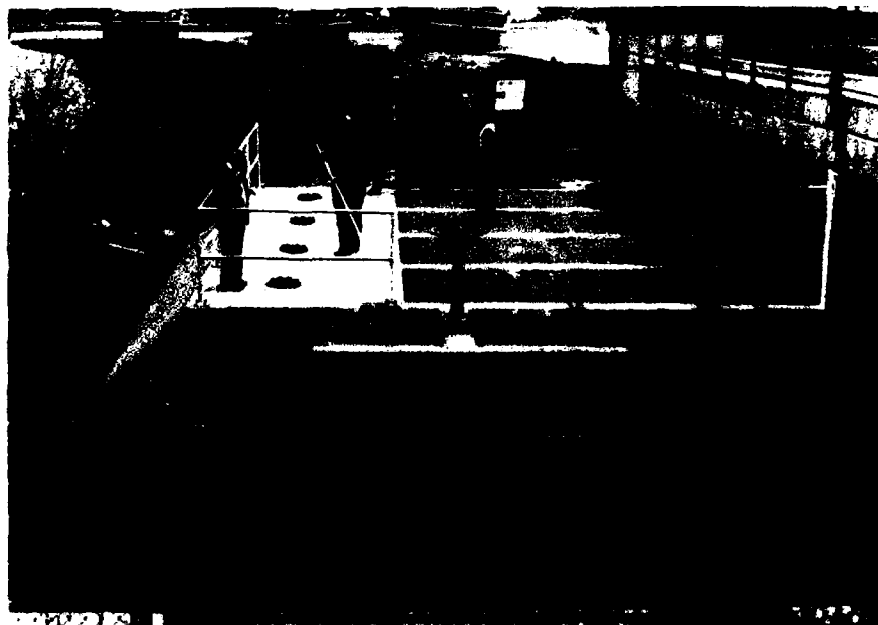
10. View along crest of dam from left abutment
